GOLD BRIDGE SHIPPING Ltd

Quarterly Bulletin

Deck crane failure sheds light on lack of maintenance

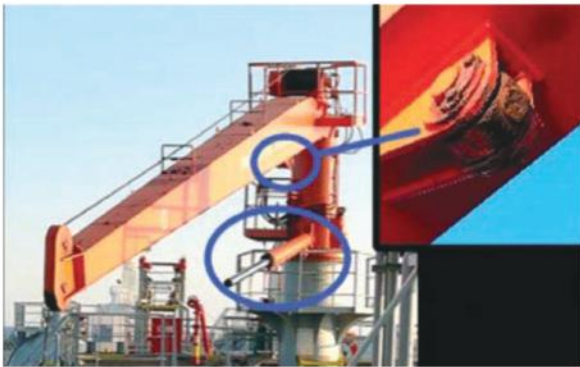
A tanker had loaded cargo and the crew were preparing to depart. The pilot was on board and the gangway (8 metres long and weighing 250kg) was to be secured for sea. It was hooked on to the deck crane, which had a safe working load (SWL) of 5,000kg, and lifted away from the ship's side, then brought slowly down to the stowed position. Just before the gangway was in the stowed position the topping cylinder broke away from the crane jib and the crane arm gave way. The gangway fell on to the deck, but as all crew had been standing clear there were no injuries and the gangway was only slightly damaged.

The company investigation found that the hydraulic cylinder eye attachment fitting had not been properly maintained. The **fitting was situated in a relatively inaccessible part** of the crane and **greasing of this part had been neglected**.

In response to this accident the greasing point of the cylinder eye attachment has been fitted with a fixed conduit so the operator can perform greasing directly from the safety of a nearby platform, as seen below.

Additionally, the job card was updated. Instead of a generic maintenance description, the new card indicates specific greasing points to help crew to identify all maintenance areas. Finally, the manufacturer reviewed the design of cylinder eye bushings. Subsequent cranes will have bushings made of synthetic material instead of metal to reduce the risk of the steel pin seizing.

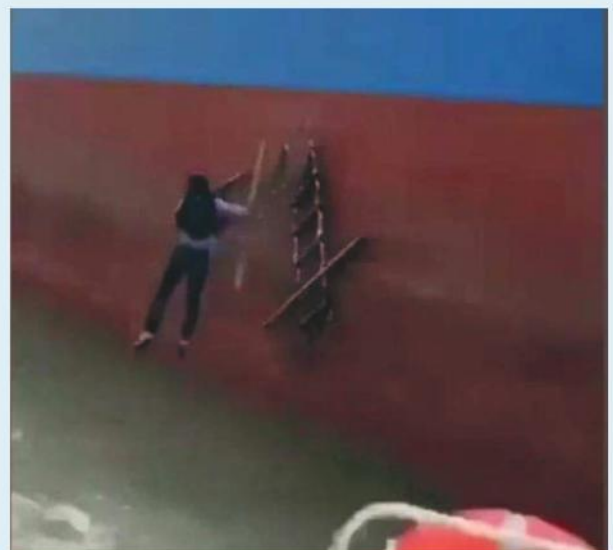
Many incidents happened where life is lost due to poor maintenance of pilot arrangements. A photo below shows the two side ropes were broken off and the person about to fall in the water.

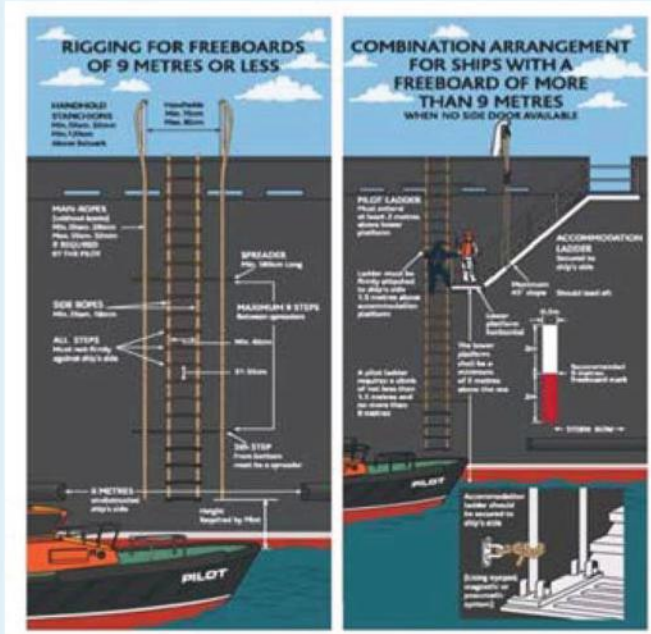
Though embarkation / disembarkation using pilot ladder is a very common practice but risky operation as well, especially in bad weather condition. Below poster is posted on wheelhouse for familiarity of right & wrong on pilot ladder specifications.

IMO RESOLUTION A.1045/27 specifies requirements for the spacing of steps, location of spreader, clear of possible discharge, each step rest firmly on ship side, distance between each step, the rope diameter to use etc.

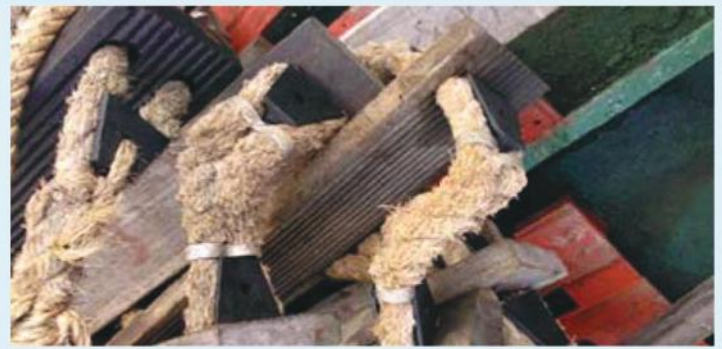
- Each pilot ladder shall be certified by the maker and have an identification number for survey, inspection and record keeping.
- Management & record of pilot ladder shall be maintained for monthly inspection, repair & maintenance, date placed on service and date disposed.
- Manila rope, with diameter of side ropes 18-22mm and manrope diameter 28-32mm shall be used.
- Permanently marked at 1 meter intervals.
- All accessories of pilot arrangement including bulwark ladder, handrails, handholds, retrieval lines, fixed points on deck (eye bolts) all must be in good condition, well maintained.
- Inspection shall be carefully done on side ropes and steps, maintain non-slippery condition.

- Maintain spare rope, steps, marline, and triangular pieces for replacements.
- Stow properly, secure and cover by tarpaulins, minimize exposure from sun and seawater

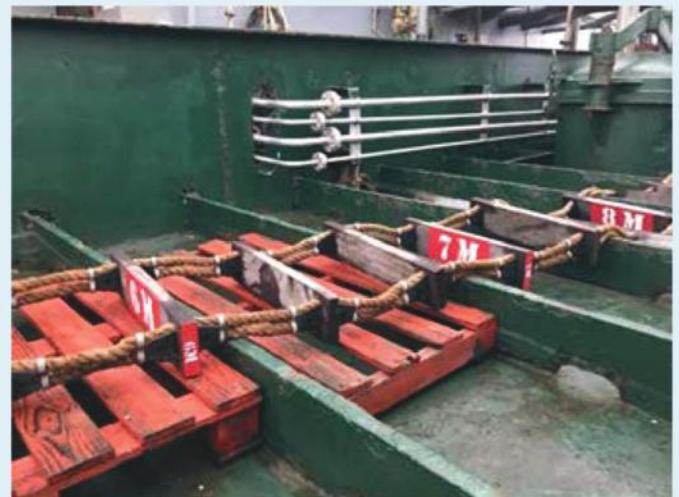
- Parting of side ropes due to poor maintenance, damage.
- Steps slippery, not horizontal, and damaged.
- Sharpened fish plate (not use rounded plate) may cut side ropes unnoticed.
- Side ropes or its splices covered by canvas have deteriorated unnoticed.
- Boarding during bad weather.
- Fatigued, overweight, hypertension and height syndrome.

- Careful visual inspection shows side ropes damaged.
- Replace side ropes at yearly interval or before based on visual inspection.

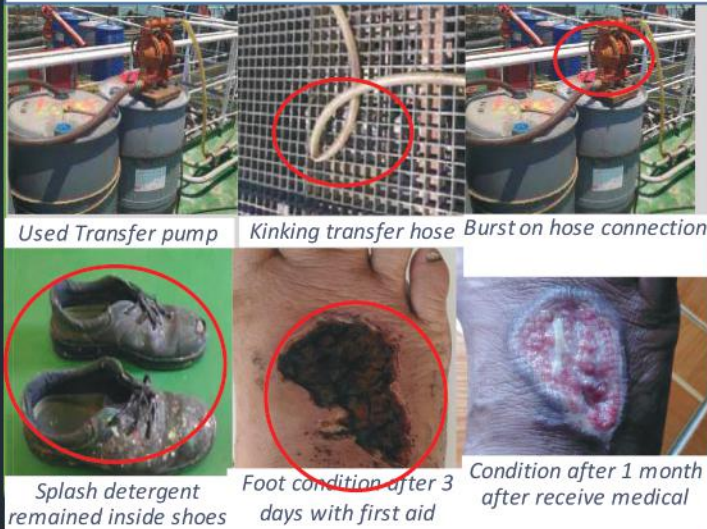
Used Transfer pump

Kinking transfer hose

Burst on hose connection

Splash detergent
remained inside shoes

Foot condition after 3
days with first aid

Condition after 1 month
after receive medical

- Transfer hose was kinked at middle part, not noticed by the crew.
- Proper PPE were not used.
- Did not take off shoes and foot was not washed.
- Injured crew and ship did not raise an alarm for prompt & proper medical treatment.
- Crews were not aware with the corrosive hazards of detergent.

- Crew awareness on hazards identification of chemicals to enhance.
- If skin contact, remove clothes, shoes to minimum and wash with plenty of water.
- Be familiar with First aid measures;
- Be familiar and implement PPE requirement;
- Report to the Master and Company without delay.
- Carry out briefing & toolbox meeting;
- If you are in doubt, still report, do not hesitate.
- Be vigilant, check before you act.
- Prepare equipment properly before use.

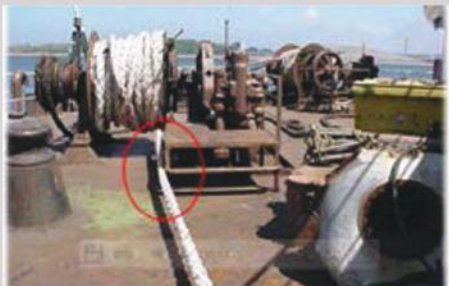
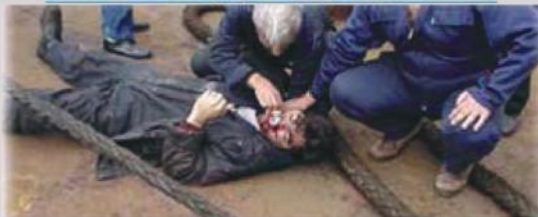
Photos (see below):

- Mooring / equipment poor condition;
- Type of mooring incidents;
- Crew Injuries;
- Poor operational practice;
- Poor Housekeeping;
- Unsafe vs good practices;

- Check control measures on Risk assessment for equipment failure, slip, falls & injury and safety are in place;
- Inspect Housekeeping & Test mooring winches;
- Proper PPE worn;
- Tool box talks before Operation;
- Supervision & maintain communication by Competent deck officer;
- Sufficient trained manpower;
- Be alert, vigilant and stay away from possible snap-back hazard.

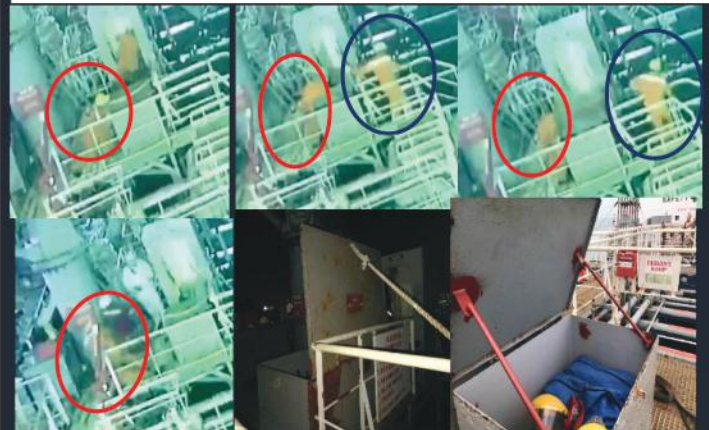
- Vessel prepare for loading arm connection after alongside jetty.
- Two ratings came to collect gears from cargo gear box. AB (A) opened the box, AB (B) went to adjacent shelter box and returned to get gear from the box.
- AB (A) is supposed to secure the cover by ropes on hand rail, but he released the cover thinking AB (B) was holding the cover.
- AB (B) thought AB (A) has lashed / secured the cover, he bent in and moved his head inside cargo gear box.
- The box cover came down by gravity in seconds and hit AB (B), his safety helmet fell down in the box, the cover end has stroked his forehead.
- AB (B) fell down on deck and AB (A) and other crew came down to assist.
- AB (B) was given first aid, send ashore by urgent arrangement, treated and returned ship in few hours.

- Job started without securing the cover.
- Split responsibility not discussed.
- Unsafe crew culture & practices.
- Rushing without visual / verbal confirmation.
- Complacent, Negligent, not following a simple "Unwritten work permit".
- No communication.

- Visualize hazards & ensure controls in place;
- Discuss, communicate & toolbox talk;
- Ensure it is safe to start work;
- Appreciate Master's prompt report to DPA, DPA involved ERT, local agent & effective group communication.
- Install angle holder / support bar for such covers
